# Manhole Inspection Summary

Manhole # S08EE2008MH

**Location** Address: **3700 Brookcrest Wy**

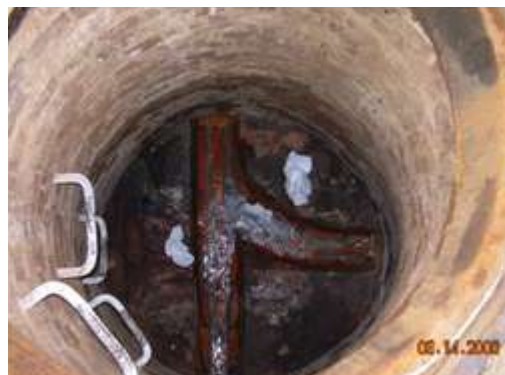
Top View

☐ Parged ☒ **Debris** (not Condition related)

Bench debris

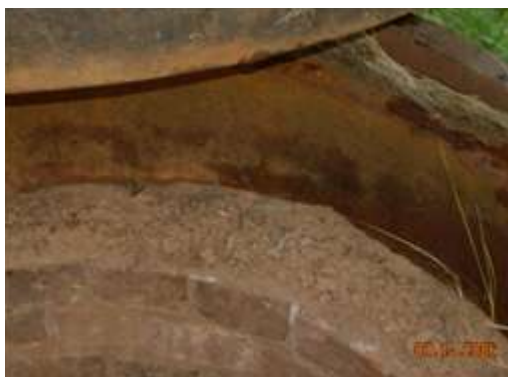
Defect

Infiltration: ☐ None ☒ **Joint** ☐ Cracks ☐ Mortar ☐ Roots ☐ Wall

Adjustment infiltration.

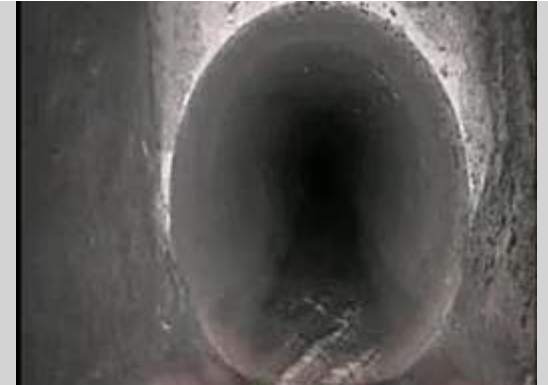
### 8 in. Circular Gravity Sewer Pipe Out @ 12 O'Clock

Invert Depth: **7.30** (ft.) Flow Characteristics: **Slow**

Deposits: ☒ None ☐ Mud ☐ Sludge ☐ Debris ☐ Grease

Infiltration: **None** Pipe Seal Cond: **Unknown**

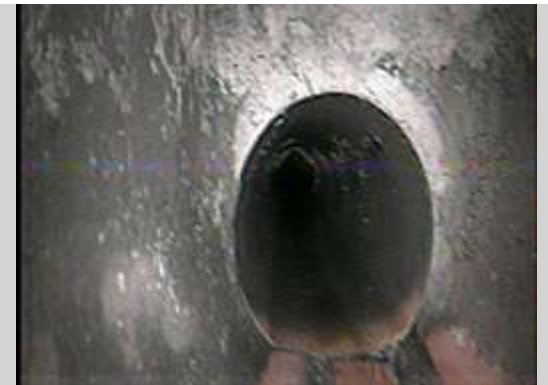
### 6 in. Circular Gravity Sewer Pipe In @ 3 O'Clock

Invert Depth: **7.15** (ft.) Flow Characteristics: **Slow**

Deposits: ☒ None ☐ Mud ☐ Sludge ☐ Debris ☐ Grease

Infiltration: **None** Pipe Seal Cond: **Unknown**

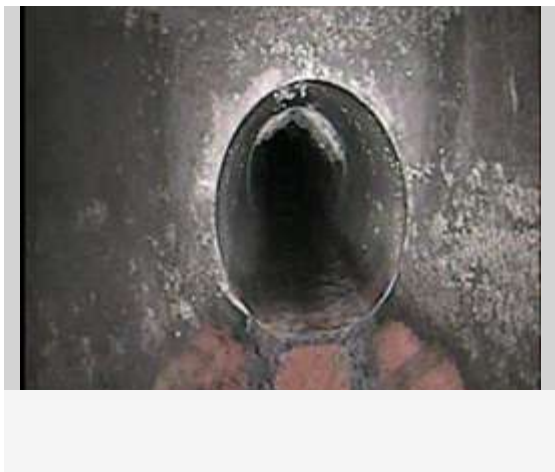
6 in. Circular Gravity Sewer  
Pipe In @ 6 O'Clock

Invert Depth: **7.10** (ft.) Flow Characteristics: **Slow**

Deposits: ☒ None ☐ Mud ☐ Sludge ☐ Debris ☐ Grease

Infiltration: **None** Pipe Seal Cond: **Unknown**
